ODD FELLOWS HOME LAKE DAM

CLAY COUNTY, MISSOURI

MISSOURI INVENTORY NO. 11022

PHASE I INSPECTION REPORT

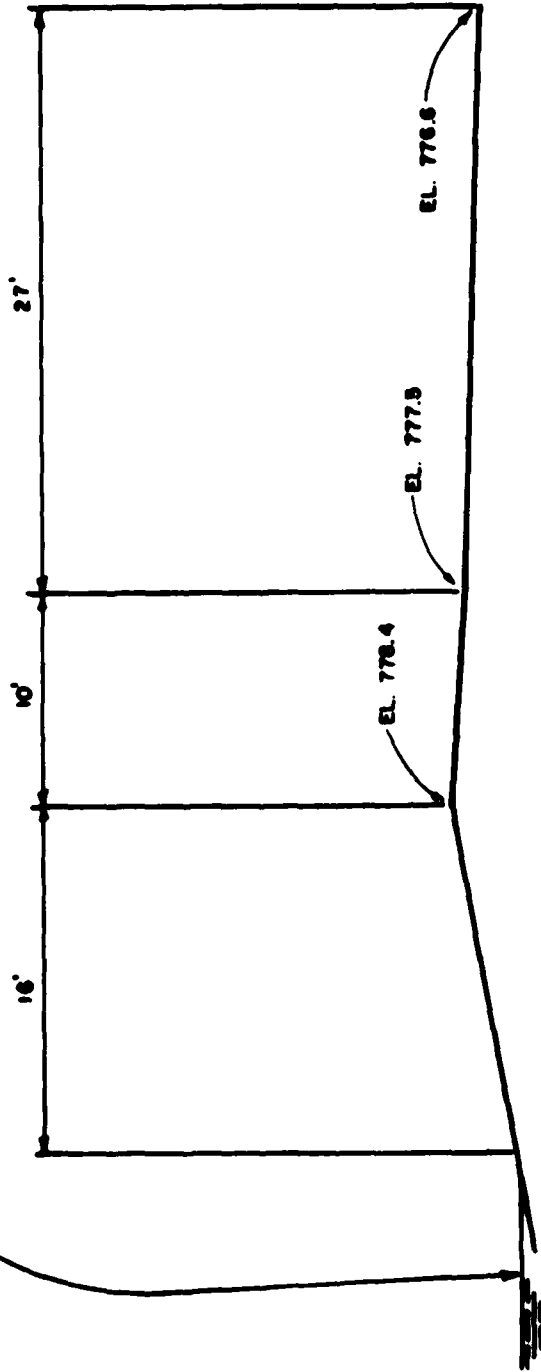
ODD FELLOWS HOME LAKE DAM DAM CROSS SECTION

ODD FELLOWS HOME LAKE LEVEL
AT TIME OF INSPECTION EL. 774.8

NOTE: CROSS SECTION TAKEN
NEAR STATION 4 + 00
